# Corrosion Analysis of Oil Drilling Pipes On Mobile RIG # 42.3 / N1500-E In Prabumulih

Volume 2, Issue 2, December 2020

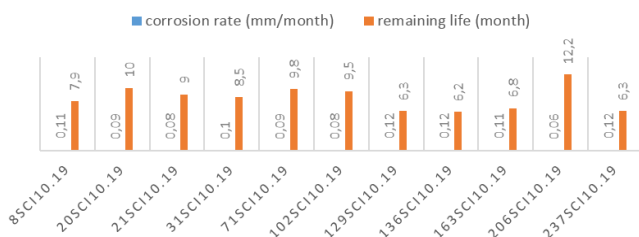
**Figure 2.** Corrosion Rate and Remaining Life

Based on Figure 2, it can be seen that the difference in corrosion rates for the same type of pipe is due to differences in the rotation speed of the drilling, which when the temperature increases on the pipe surface causes  $Cl^-$  activity to increase, thereby reducing the composition of  $Fe_2O_3$  by electrochemical reactions and damaging the structure of the oxide layer on the pipe [9]. The smallest remaining age is in the serial number 237SCI10.19, which is 6.3 months, while the largest remaining age is in the serial number 206SCI10.19, which is 12.2 months.

For the calculation of the corrosion rate consider the first inspection report and the second inspection report with a span of 17 months.

Based on the corrosion rate, the remaining life of the drilling pipe can be predicted to a minimum of 6.44mm. With the interim data, the minimum thickness of 7.2 mm is included in the calculation. By looking at the remaining life, it is close to the minimum standard limit to the minimum limit allowed by the DS-1 Volume 3 standard of 6.44mm (70% of the initial thickness).

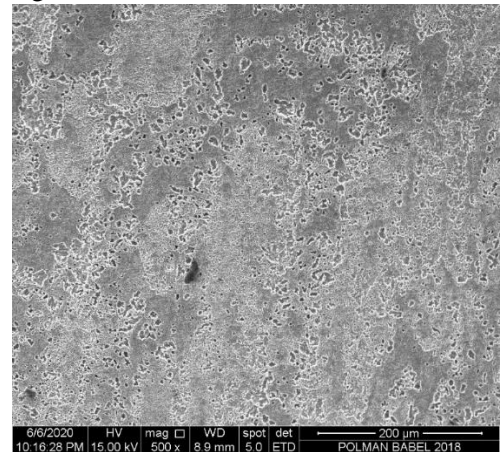
**Figure 3.** SEM Test Results 500X Magnification for Sample 129SCI10.19

SEM testing is used to see the form of corrosion that occurs in the specimen. SEM analysis was performed at 500X magnification.

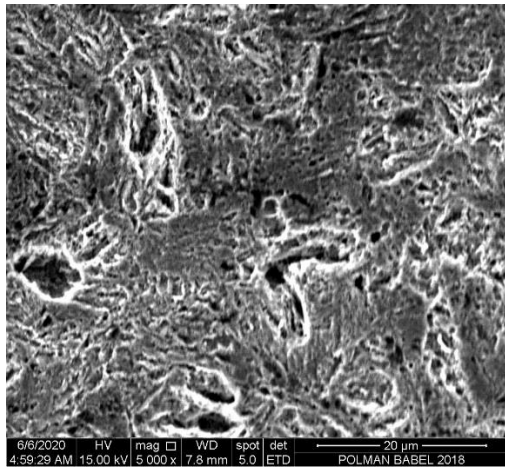
**Figure 5.** SEM Test Results 500X Magnification for Sample 136SCI10.19

In Figure 5, there is a windmanstatten structure, which is a surface exposed to two temperature differences, so that a layer is formed at a point which causes cooling to slow down causing overheating, then when exposed to lower temperatures it will cause rupture. This is in accordance with the way the drill pipe works with the fluid outside being hot, while the fluid inside the pipe tends to be cooler. The results of this study, the element of oxygen as a trigger for corrosion was found in the specimen.

Winmanstatten the structure above shows that the surface morphology of the carbon steel pipe specimen is not smooth, this is the initiation of damage to the surface due to the corrosion process. If this process is continued, the longer the corrosion products will be seen more clearly. When viewed from the results of the relatively small corrosion rate, to produce corrosion products the function of time also affects, the longer the observation time, the greater the corrosion rate value, besides that the corrosion products can be visually observed. This will be followed by changes in surface morphology, these morphological changes can be in the form of holes or cracks. [9]
